*Peñuelas Valley Landfill, LLC.
PO Box 918
Punta Santiago, PR 00741-0918*

March 23, 2017

**Re: Administrative Compliance Order
Peñuelas Valley Landfill, LLC./EC Waste, LLC.
Docket Number CWA-02-2017-3103
NPDES Tracking Number PRR053203**

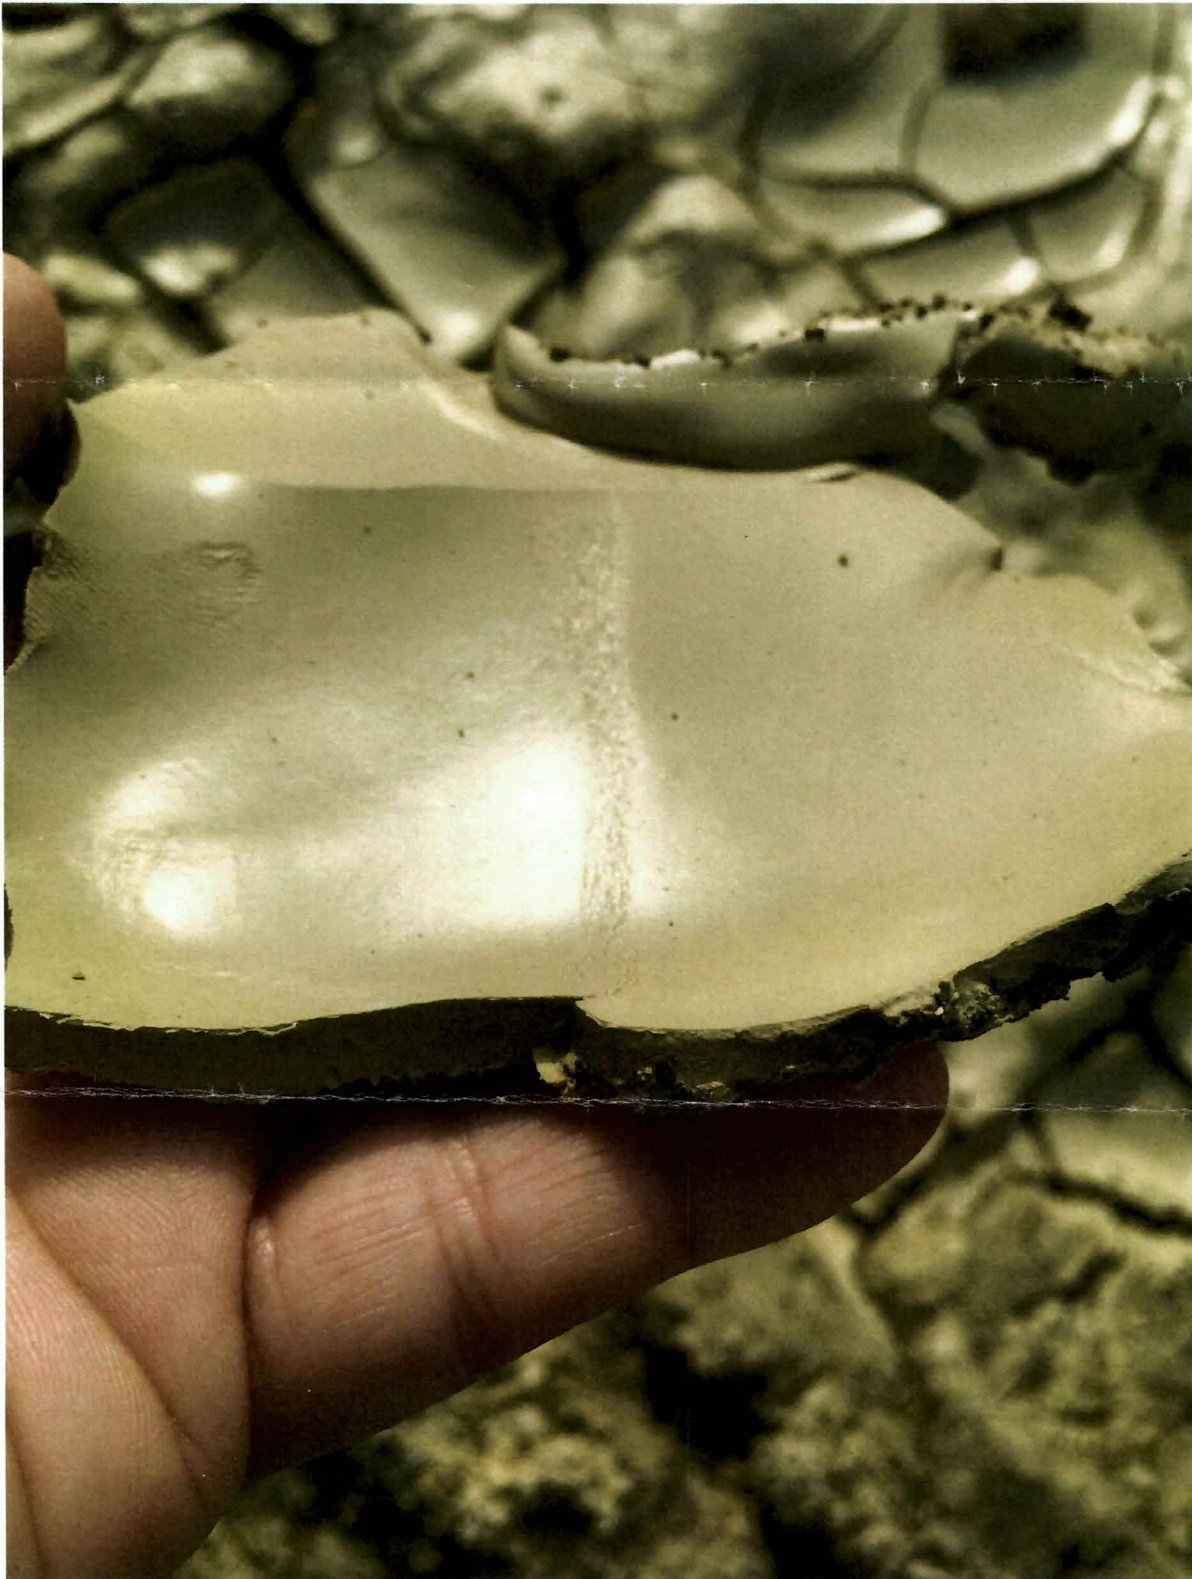
Photo 1 - Site clay material

We want to point out that the area of Peñuelas is rich in clay materials that affect the amount of sediment that could be present in the discharge regardless of control measures that are or could be implemented. Clay has the property of remaining in suspension for many days after a rain event. The presence of floating clay particles for extended periods of time will influence a discharge from the sedimentation pond. Photo number 1 shows the clay that is present onsite at PVL.

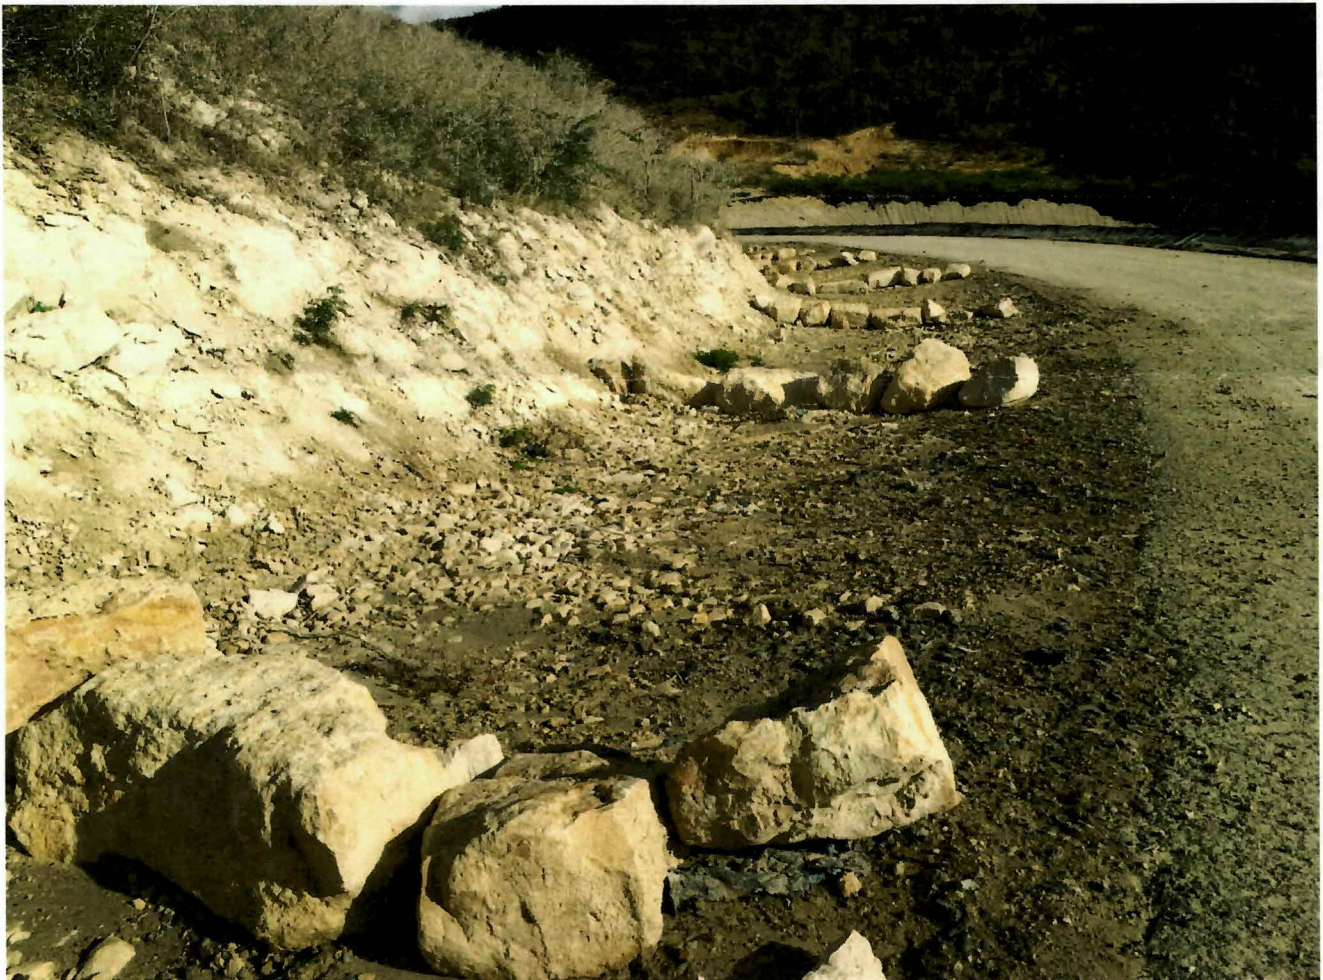
Photo 2 - Energy dissipation structures and sediment control

The site has been working in the implementation of additional measures to improve the quality of the discharge. Photos number 2 and 3 show energy dissipation structures that have been installed in one of the earthen channels around the perimeter of the cell. The structures also aid in the retention of sediments before the flow enters the concrete channels. The site had also programmed the dredging of sediments from the sedimentation pond and the construction of an intermediate berm that would increase the retention time in the pond and improve the sedimentation process. This project could not be started until the bottom of the pond is completely dry. The site began removal of sediments on March 18th but encountered very wet material just a few feet below the surface. Further drying may be required in order to complete the project. PVL will provide regular updates of this process. Photo number 4 shows the beginning of the project.

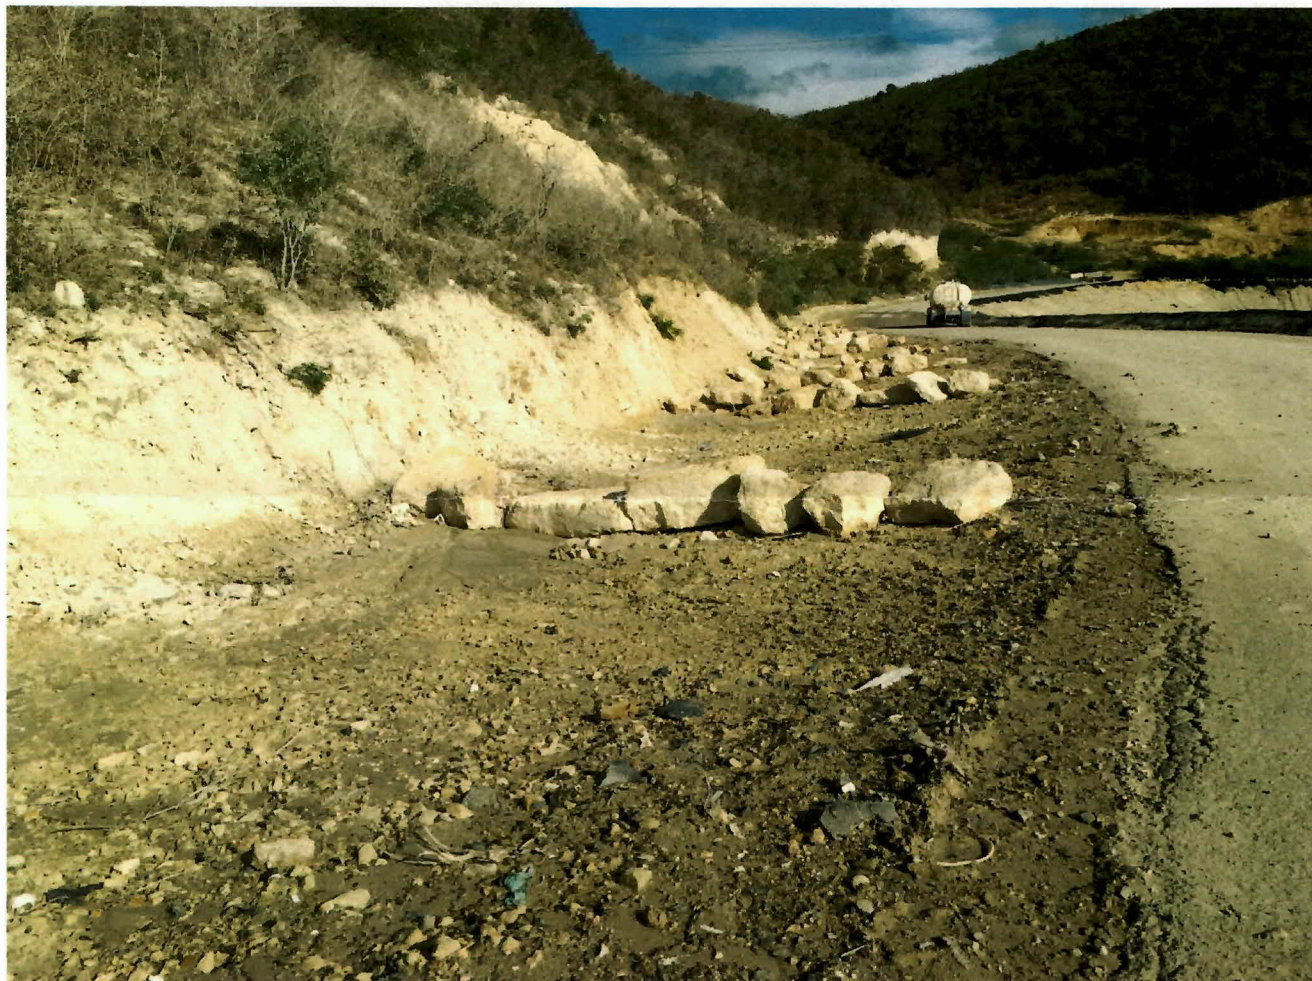
Photo 3 - Energy dissipation structures and sediment control

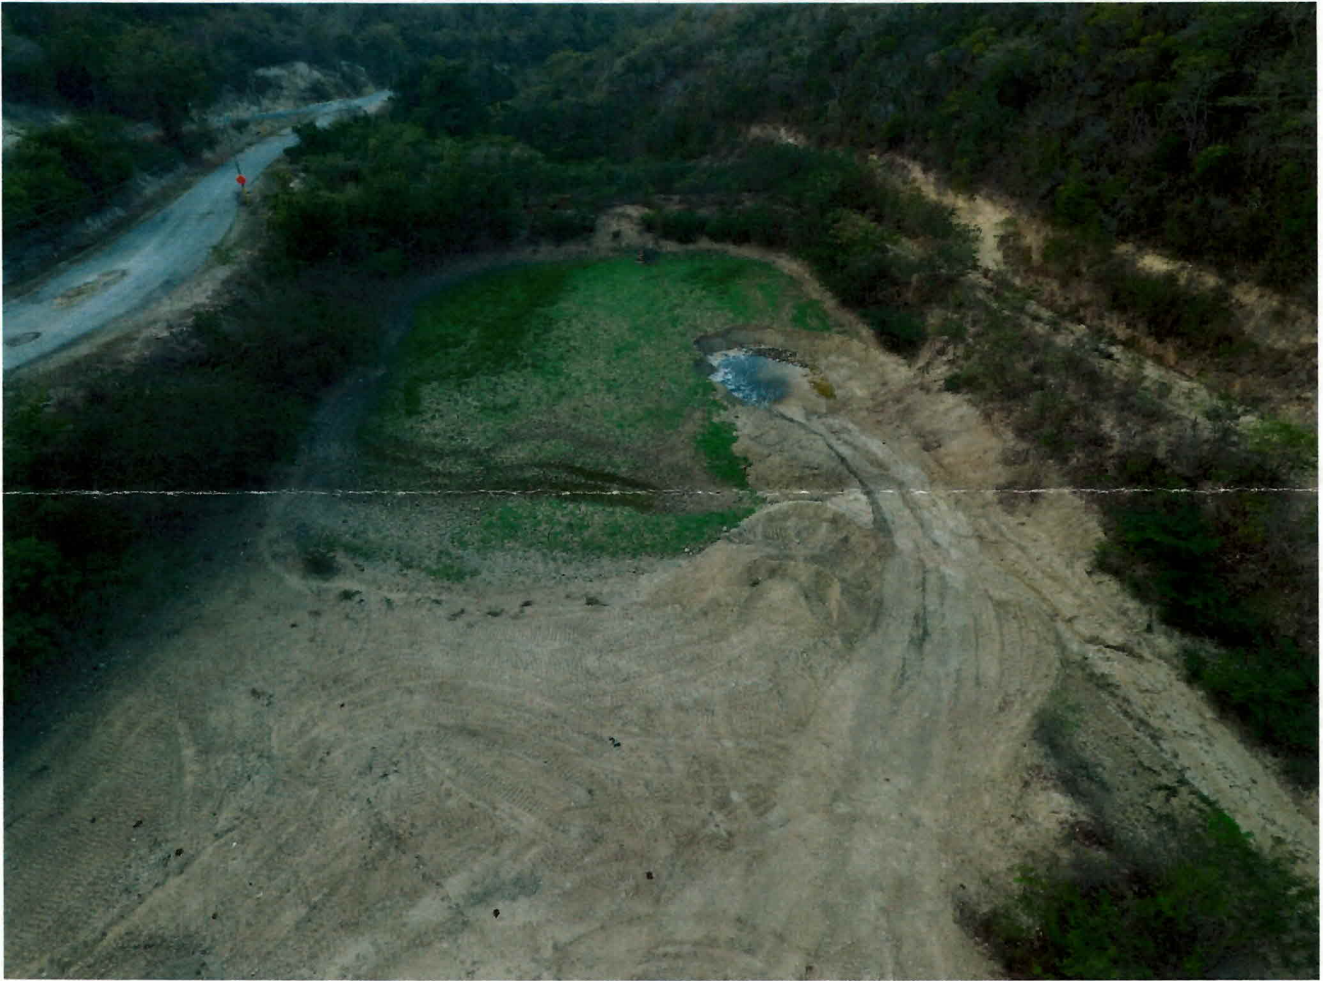
Photo 4 - Sedimentation pond
